Re: Tallyn Ridge – Combined Preliminary (AKA Glad Hill Property)  
File #S1166, Project Number 14144  
BCG Project # 5747-01-002  
FRO Staff Level Review

Issues associated with Specimen Tree 1- Refer to attached Photo Exhibit (Photo #s 1 – 25)

Issues associated with Specimen Tree 41- Refer to attached Photo Exhibit (Photo #s 26 – 36)

Issues associated with Specimen Trees 17, 18, and 19- Refer to attached Photo Exhibit (Photo #s 37 – 41)

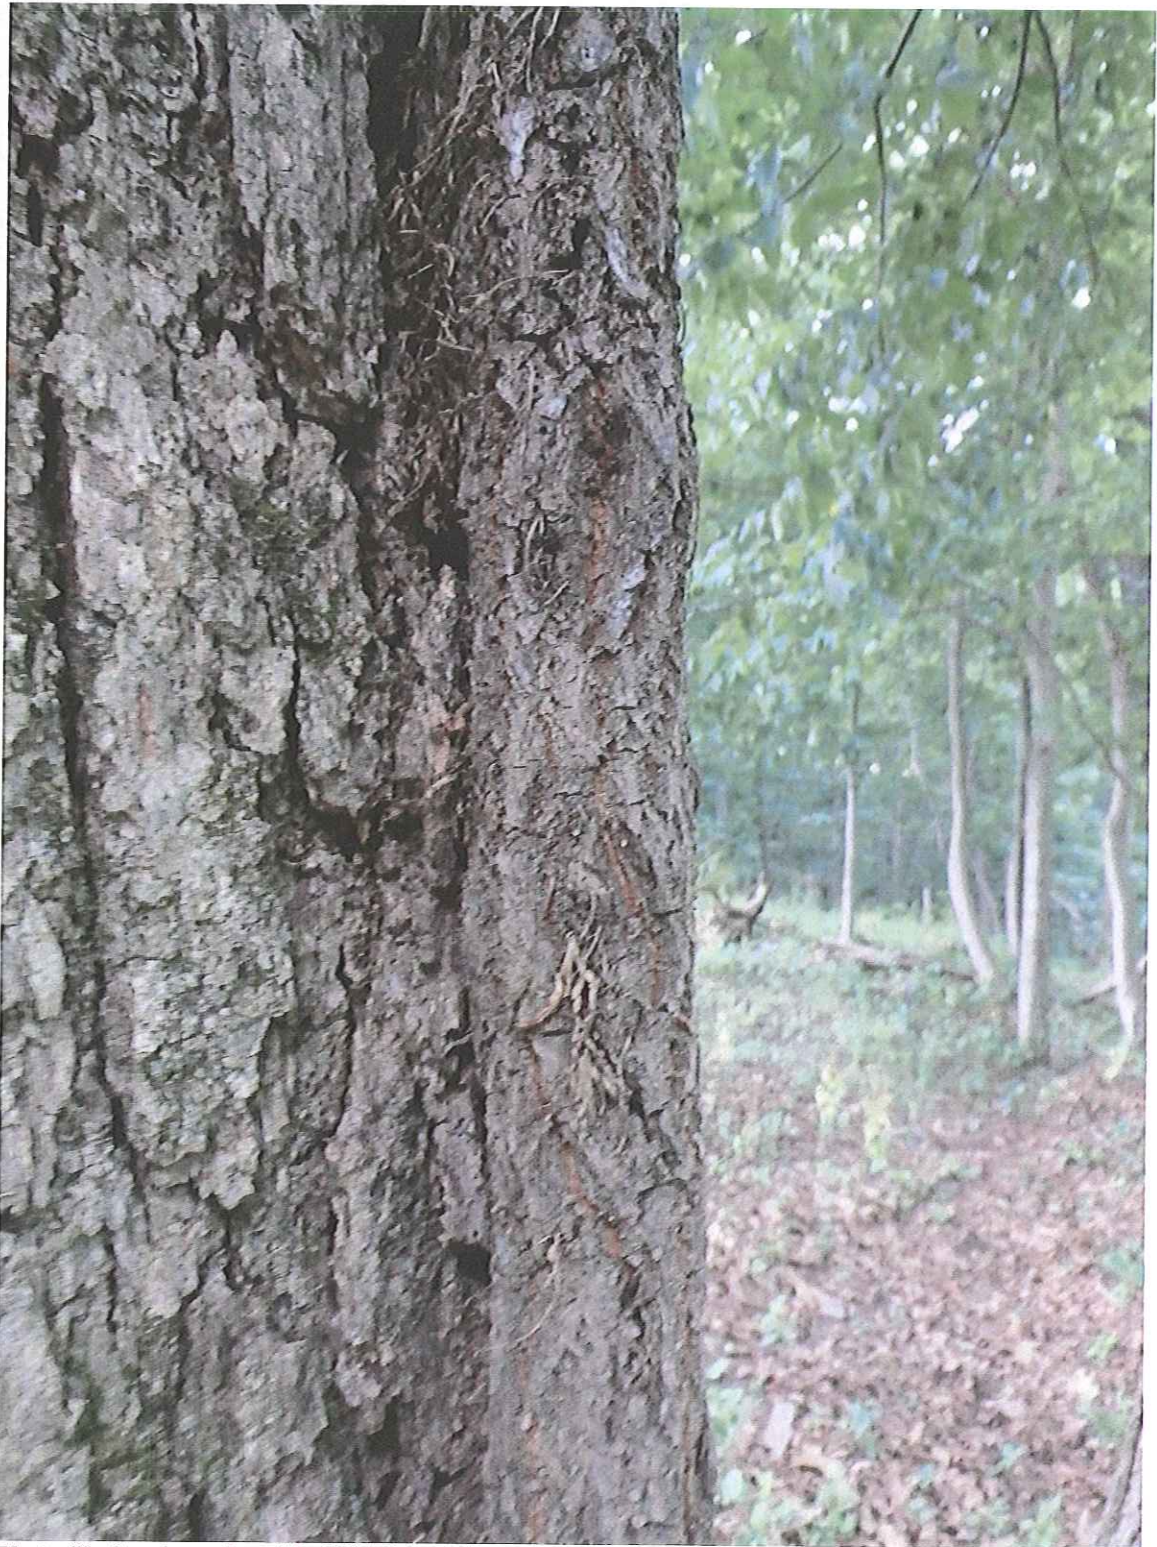
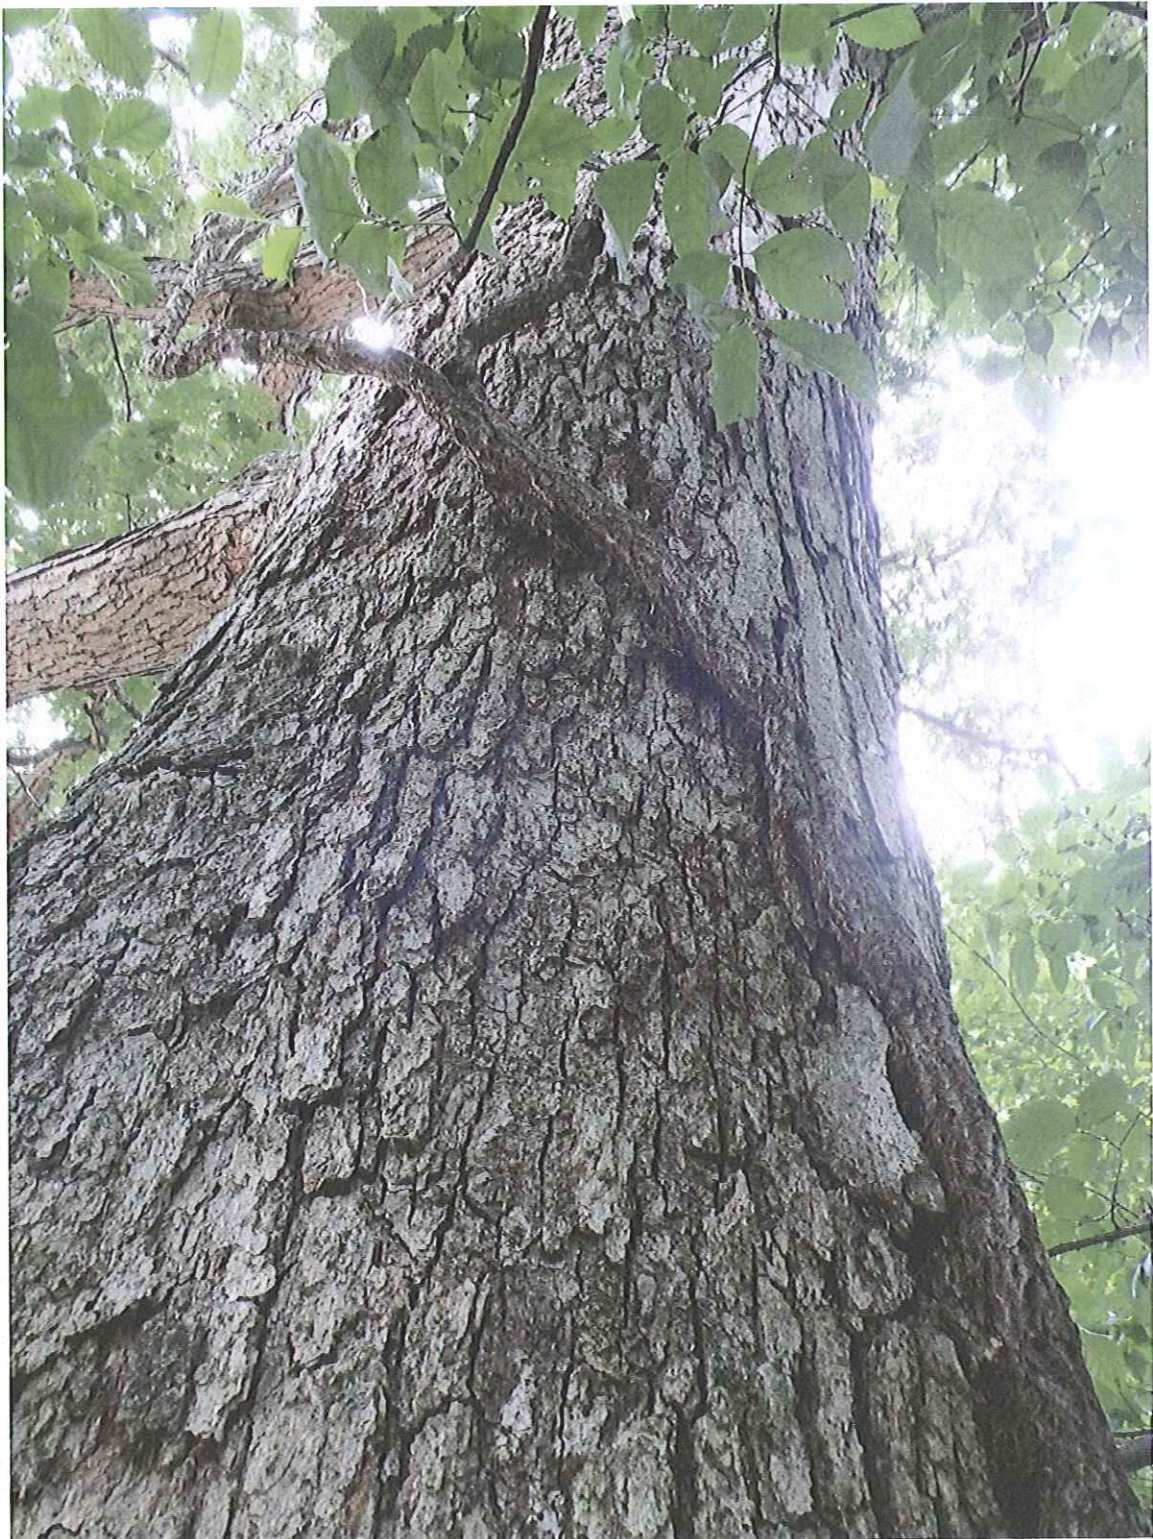
- Invasive vine cover – Can restrict light, add additional weight making the tree more susceptible to blow over during high rain, wind or snow events, strangle/choke and eventually kill the tree.

**Photo #1:** Specimen Tree #1. 35" White Oak –Invasive vine cover.

Photo #2: Specimen Tree #1. 35" White Oak – Invasive vine cover.

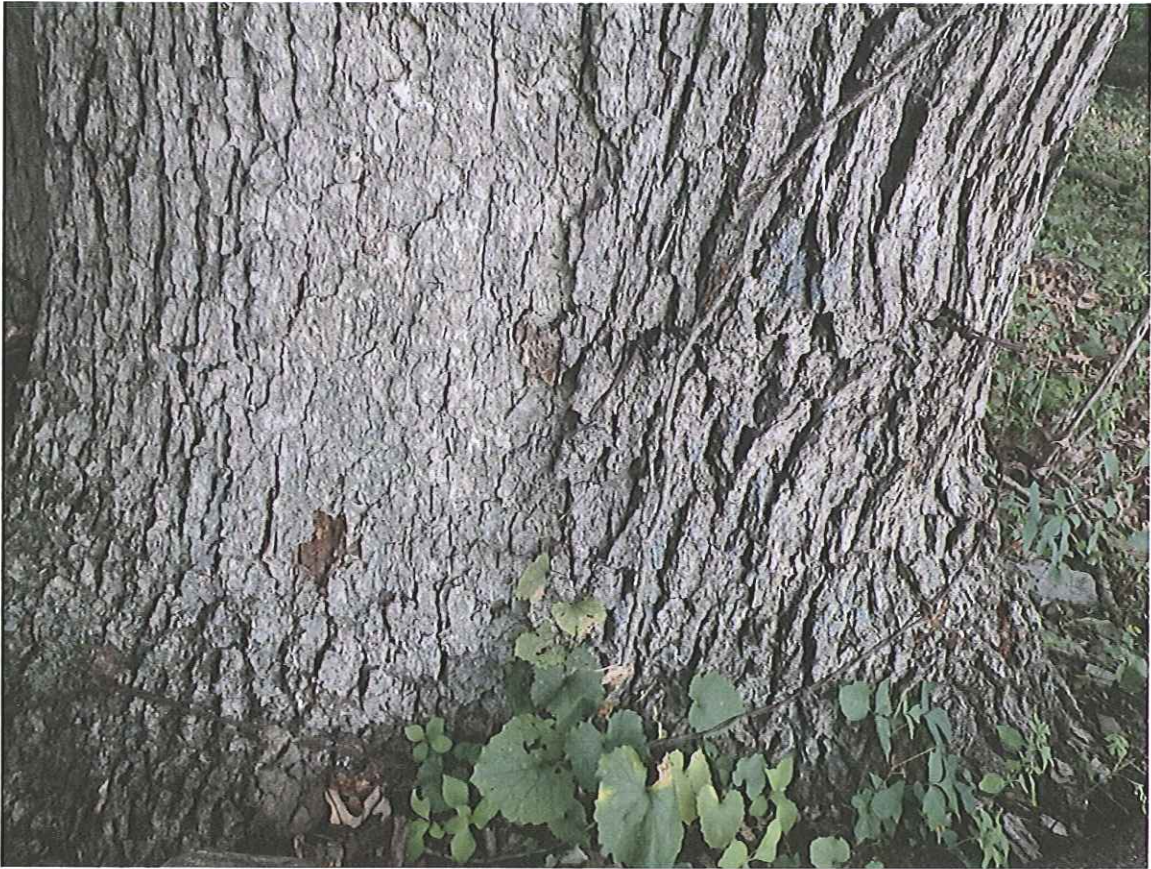
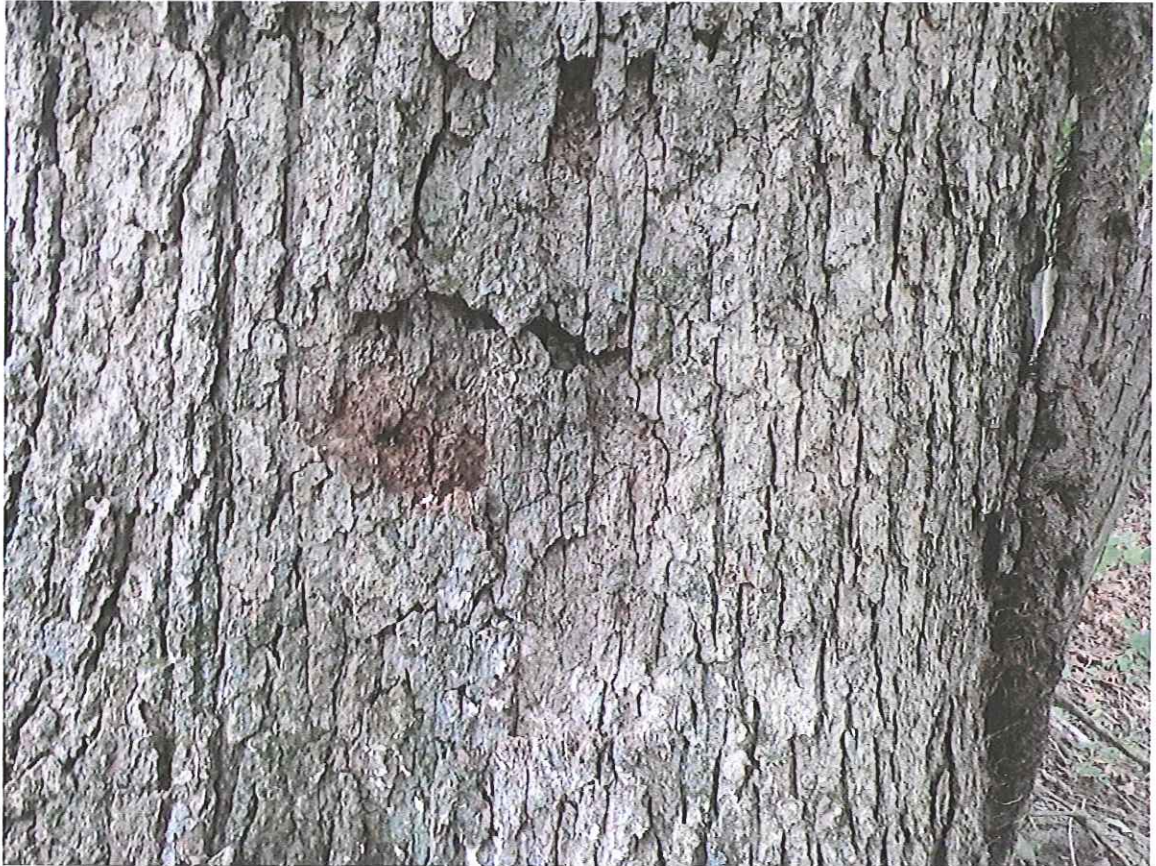
- Multiple cankers - Are among the most destructive problems of woody plants. Branches and portions of a trunk can die when cankers are present. Most cankers are caused by fungi and often create openings for other fungi, bacteria and insects which can speed up a tree's decline and health.

Photo #3: Specimen Tree #1. 35" White Oak – Multiple cankers.

Photo #4: Specimen Tree #1. 35" White Oak – Multiple cankers.

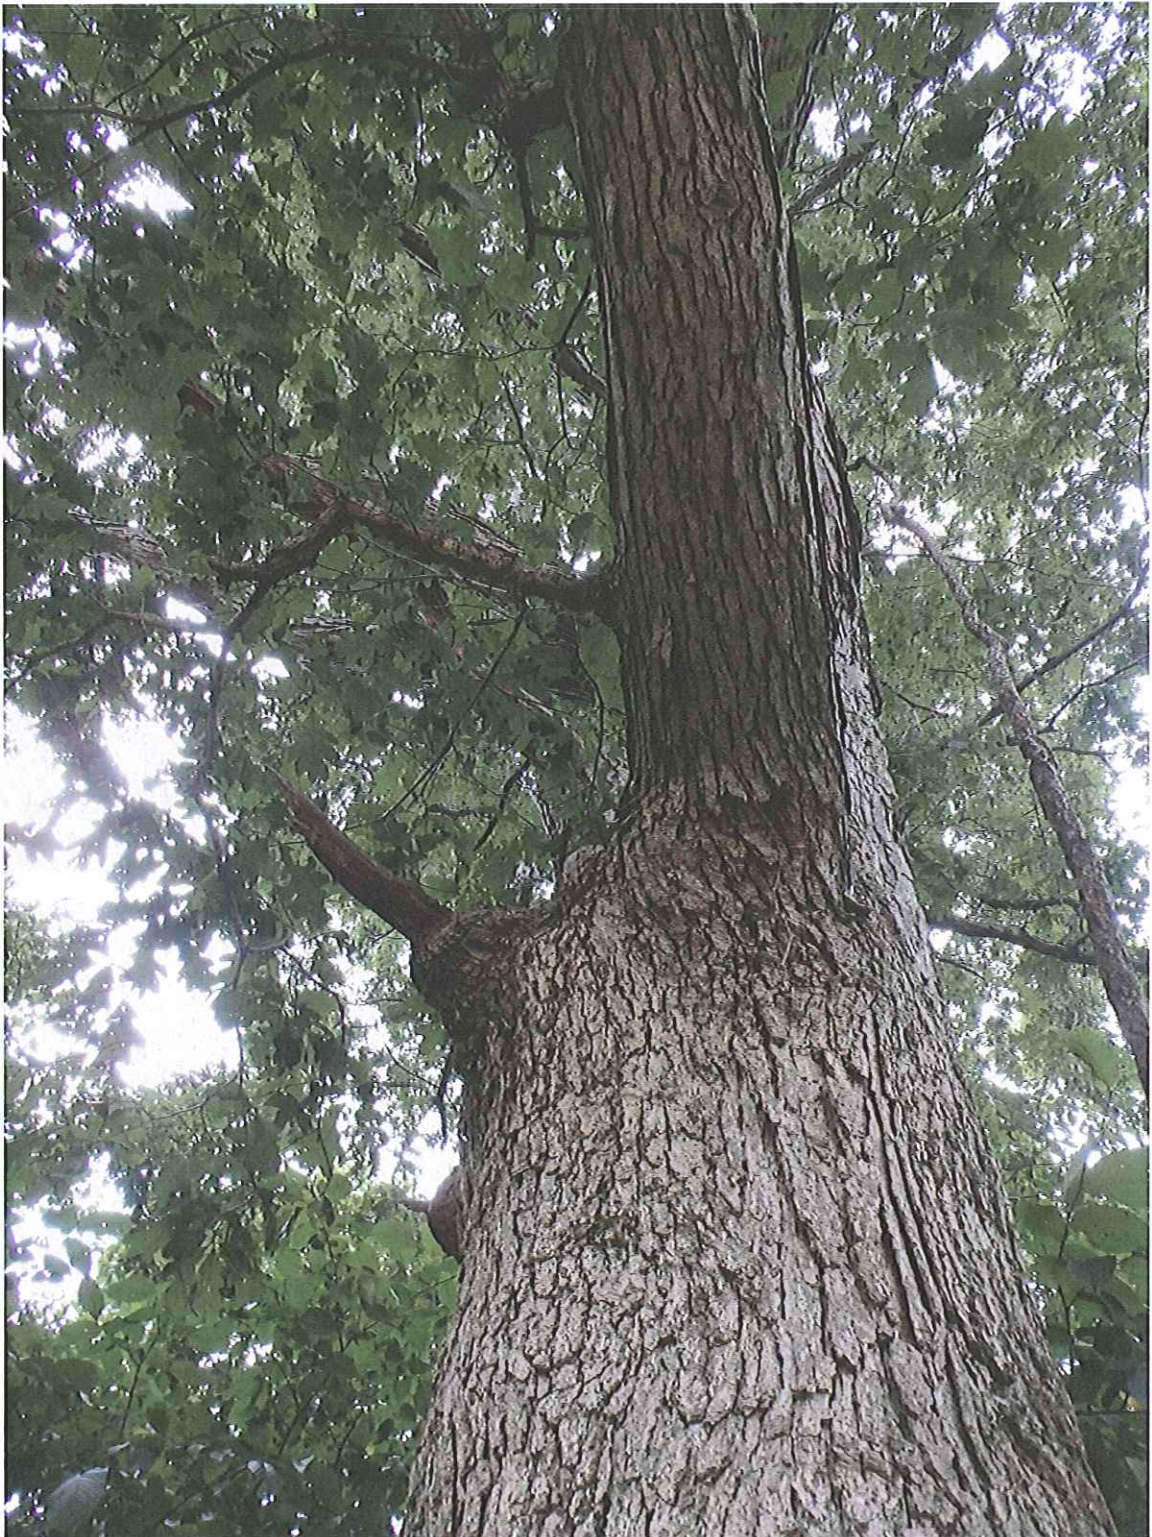
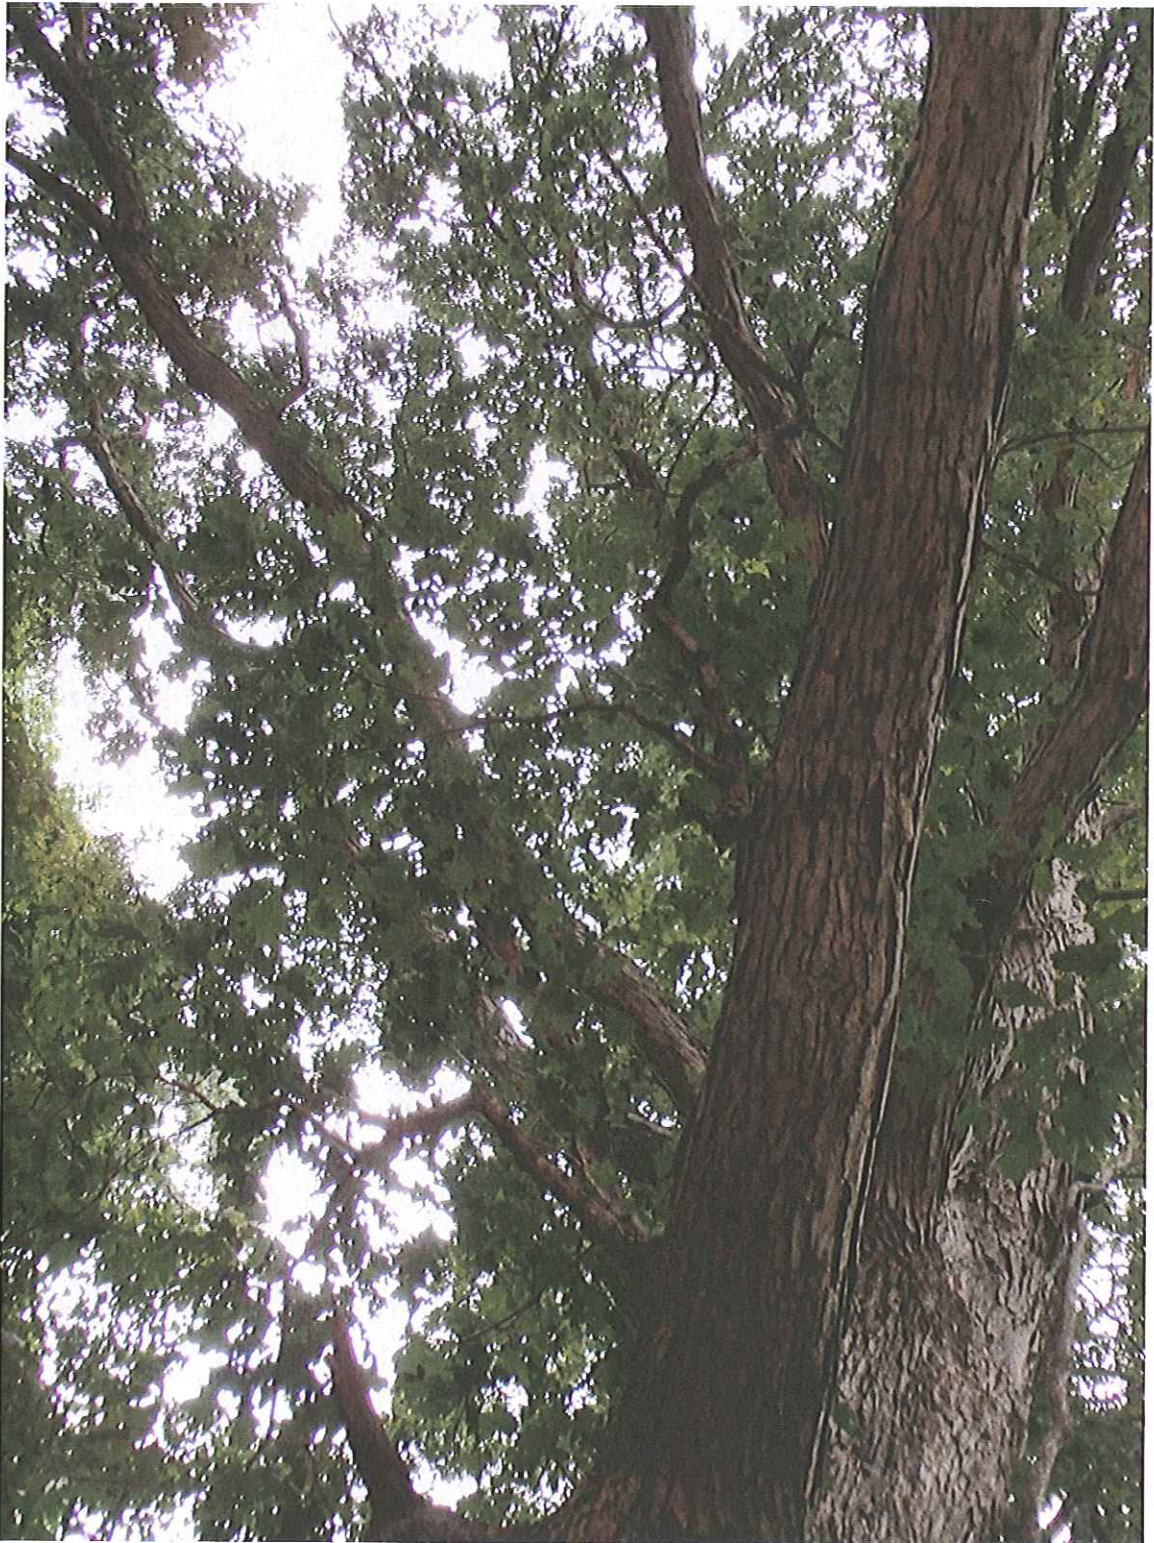
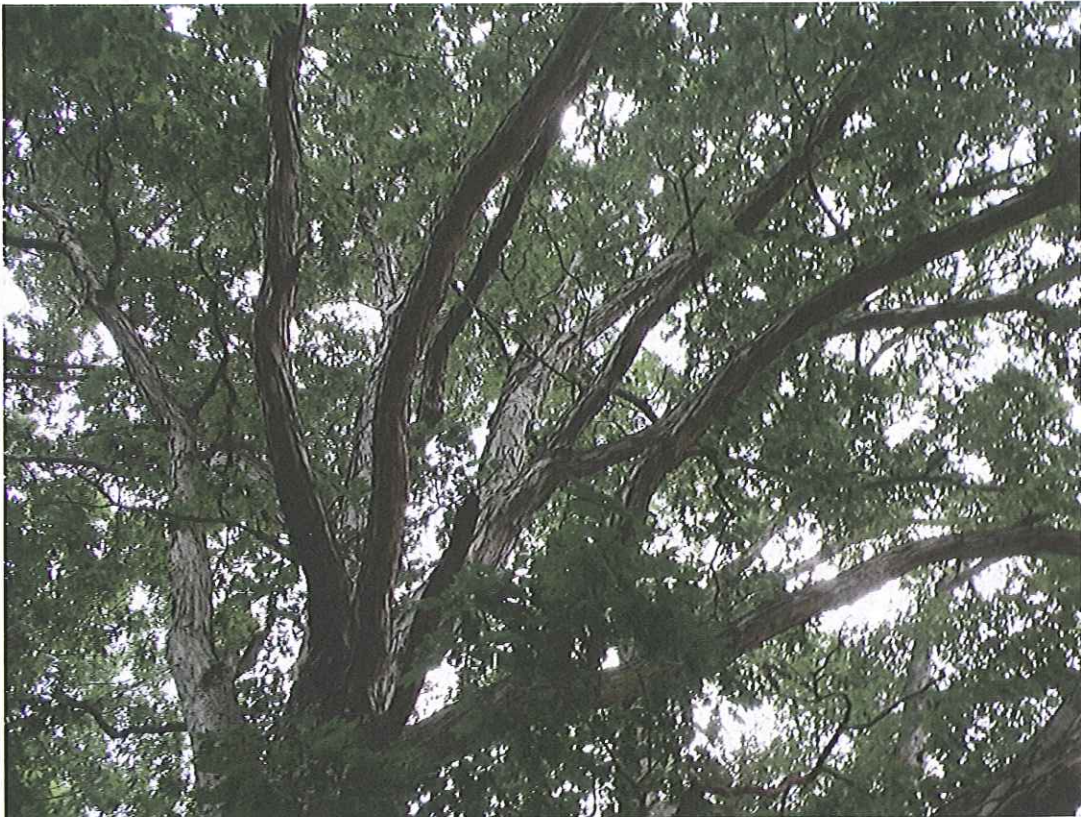
- Dead wood throughout canopy - Poses potential hazard to life and/or property on proposed adjacent community when located in the open or along forest edge.

**Photo #5:** Specimen Tree #1. 35" White Oak – Dead wood throughout canopy.

Photo #6: Specimen Tree #1. 35" White Oak – Dead wood throughout canopy.

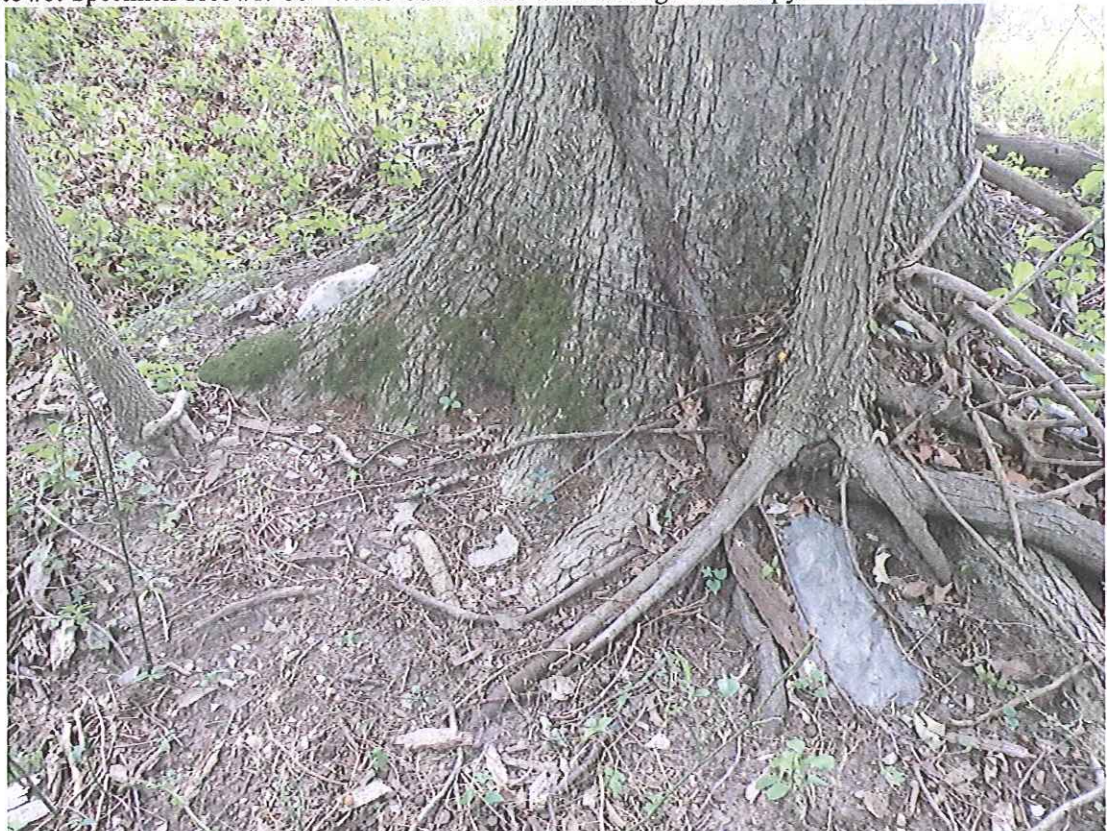
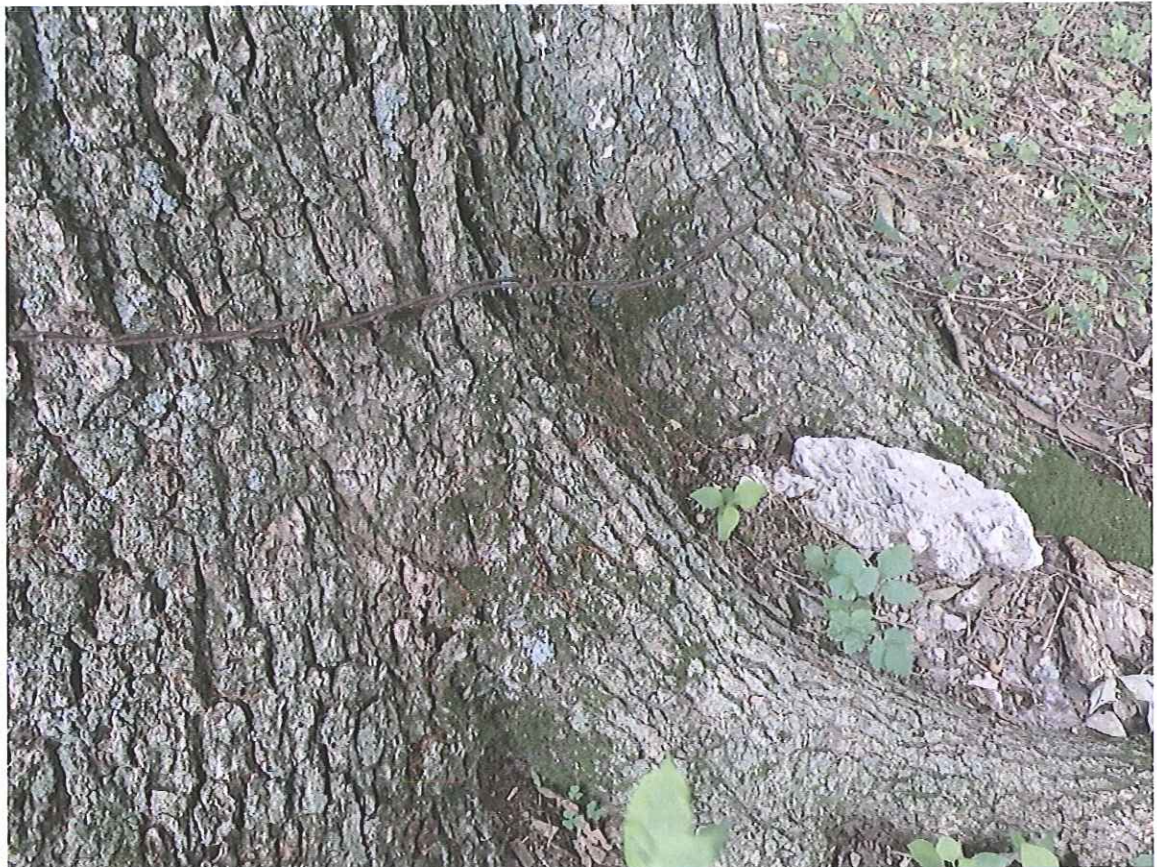
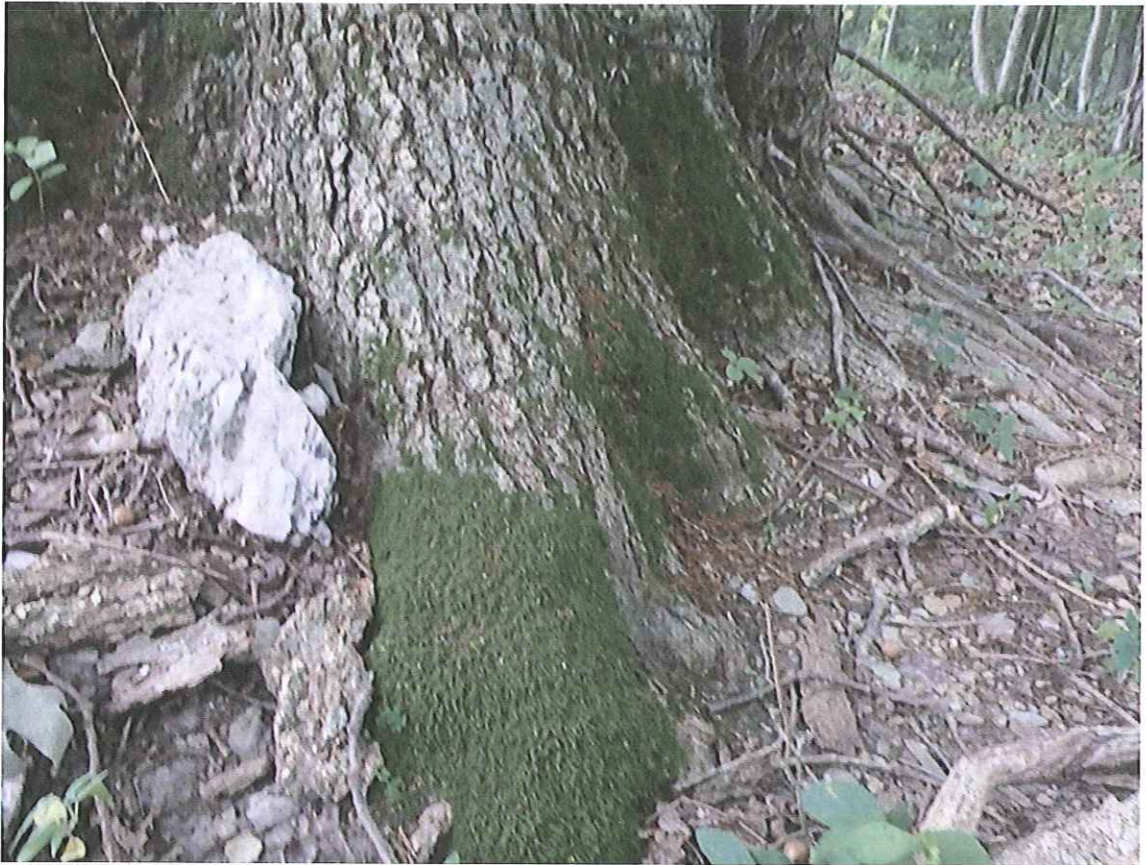
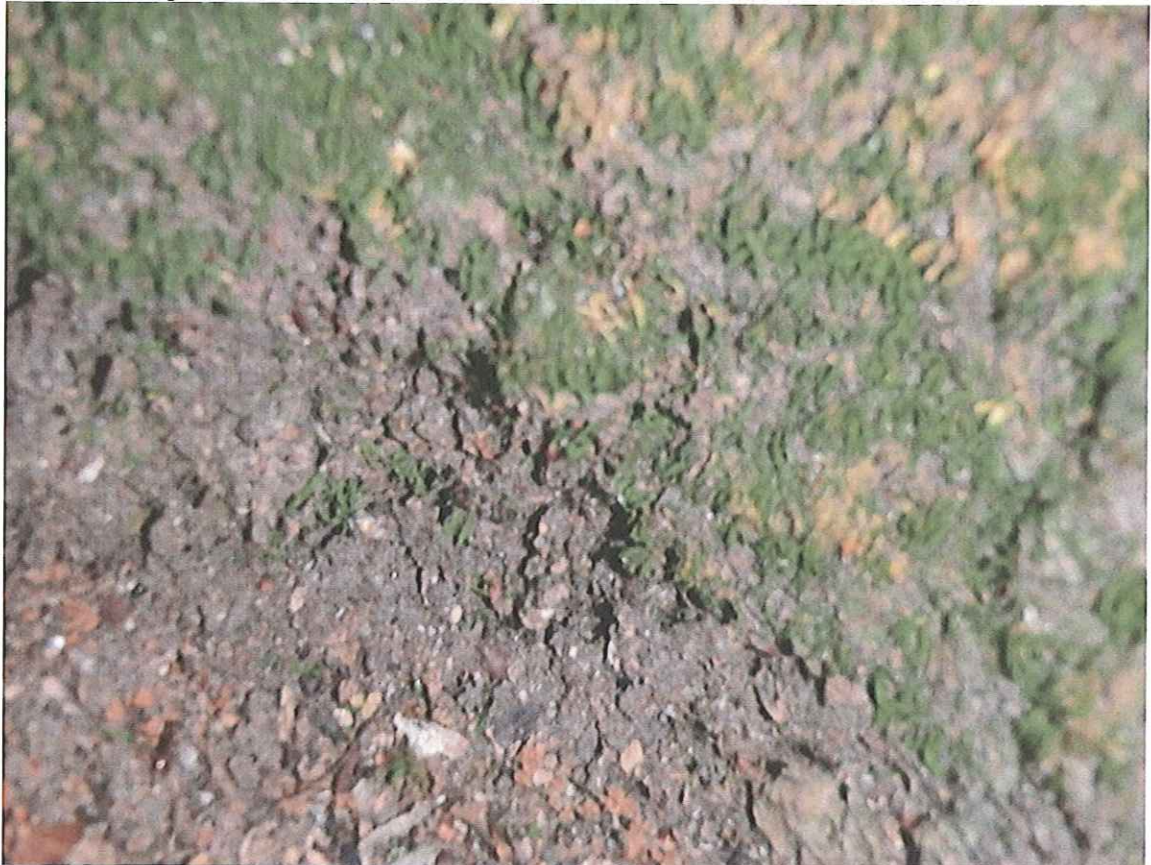
- Moss and deterioration at base - Deterioration in combination with moss at the base of tree could be a sign of root damage, which could increase the chance for tree failure. Wood rotting fungi destroy wood fiber in the root system, greatly reducing strength and resistance to wind throw.

Photo #7: Specimen Tree #1. 35" White Oak – Moss and deterioration at base.

**Photo #8:** Specimen Tree #1. 35" White Oak – Moss and deterioration at base.

Photo #9: Specimen Tree #1. 35" White Oak – Moss and deterioration at base.

Photo #10: Specimen Tree #1. 35" White Oak – Moss and deterioration at base.

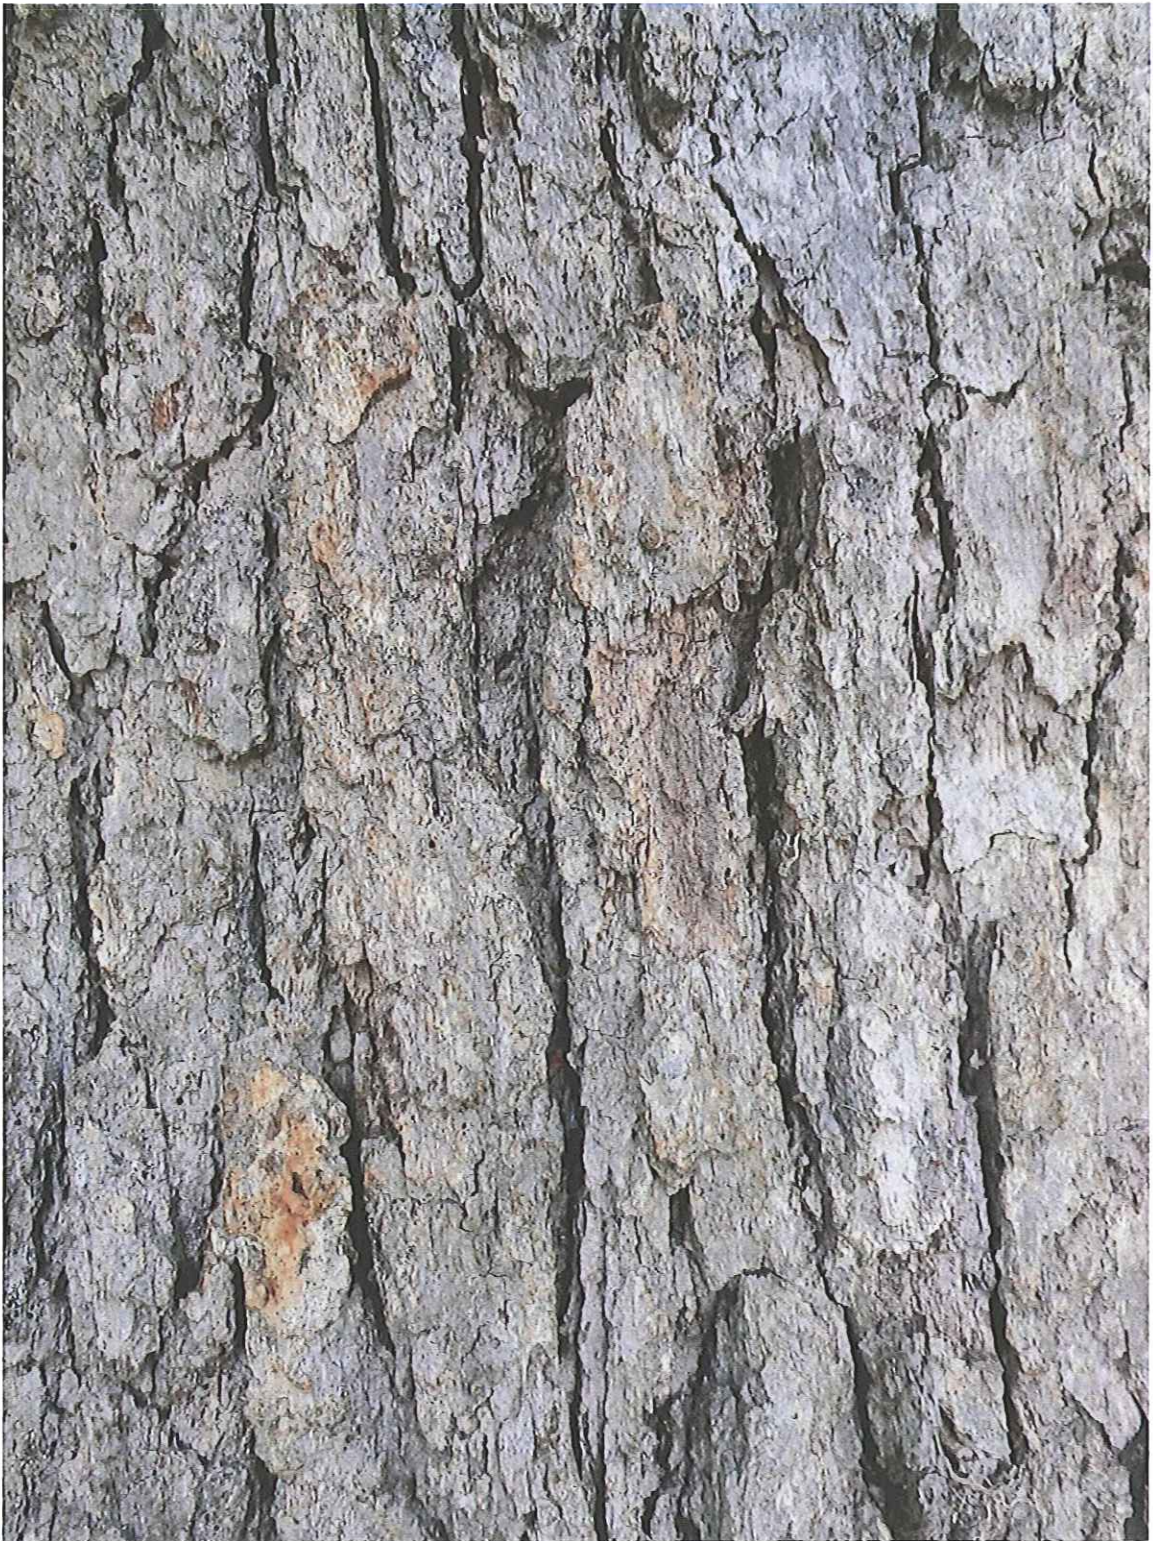
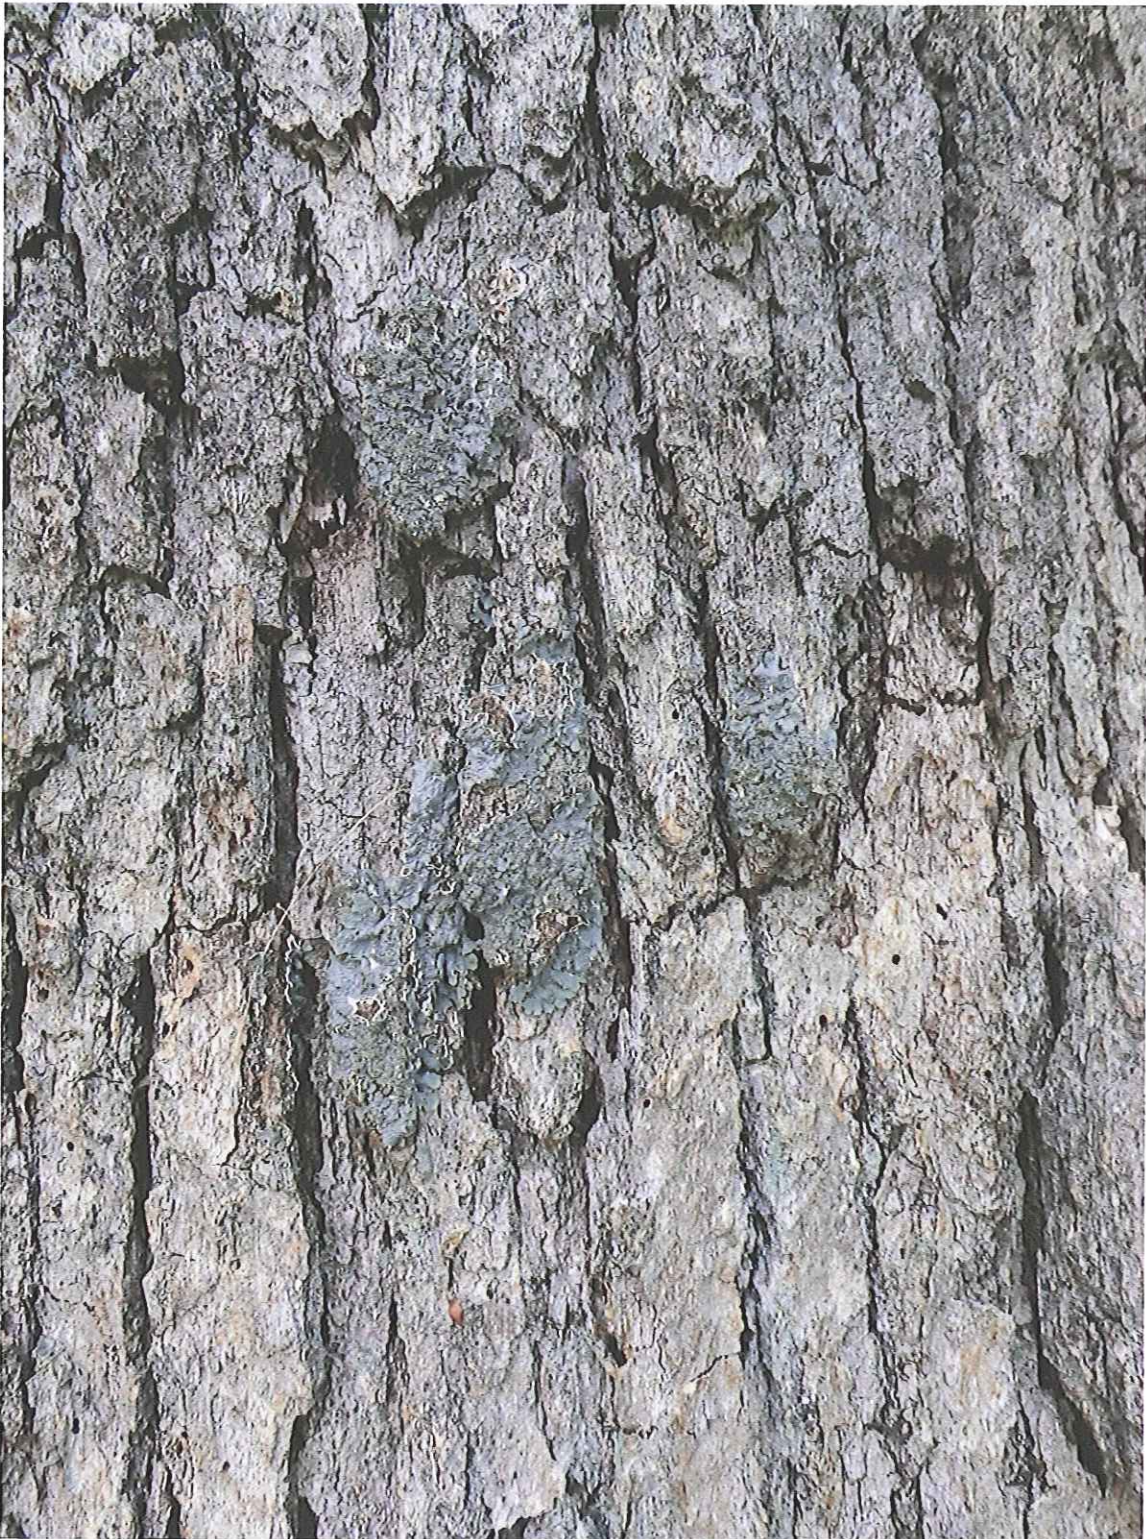
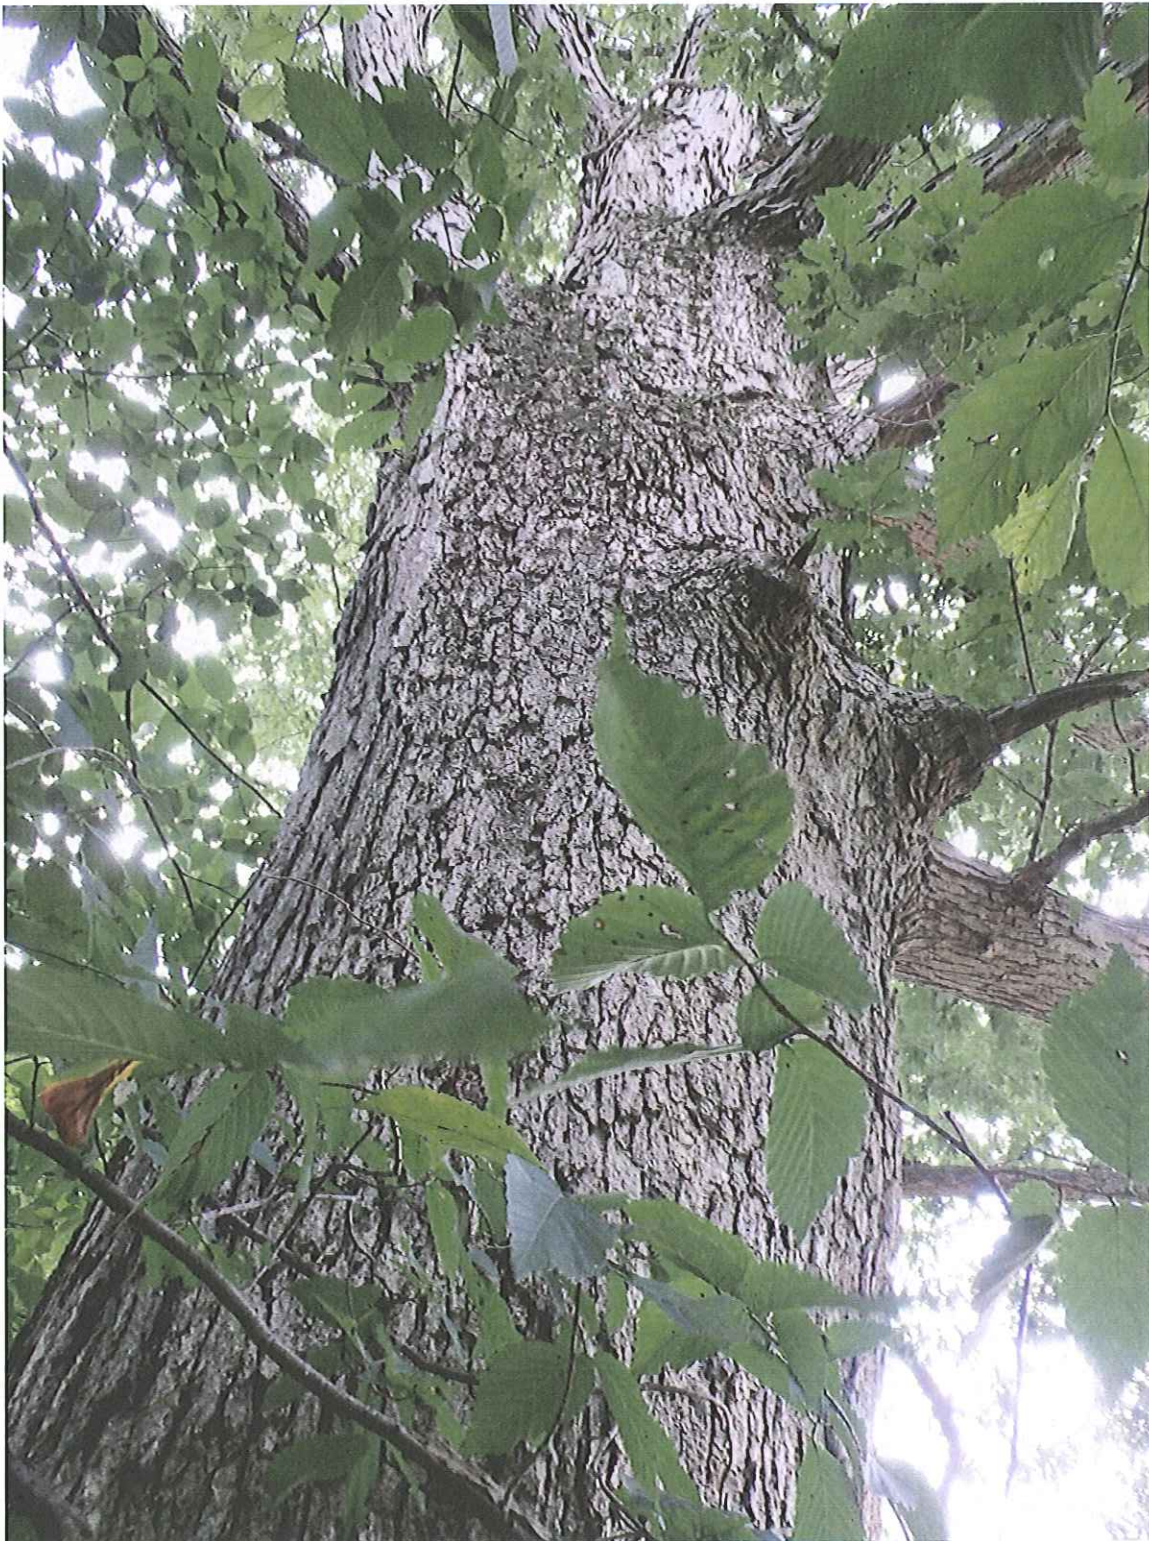
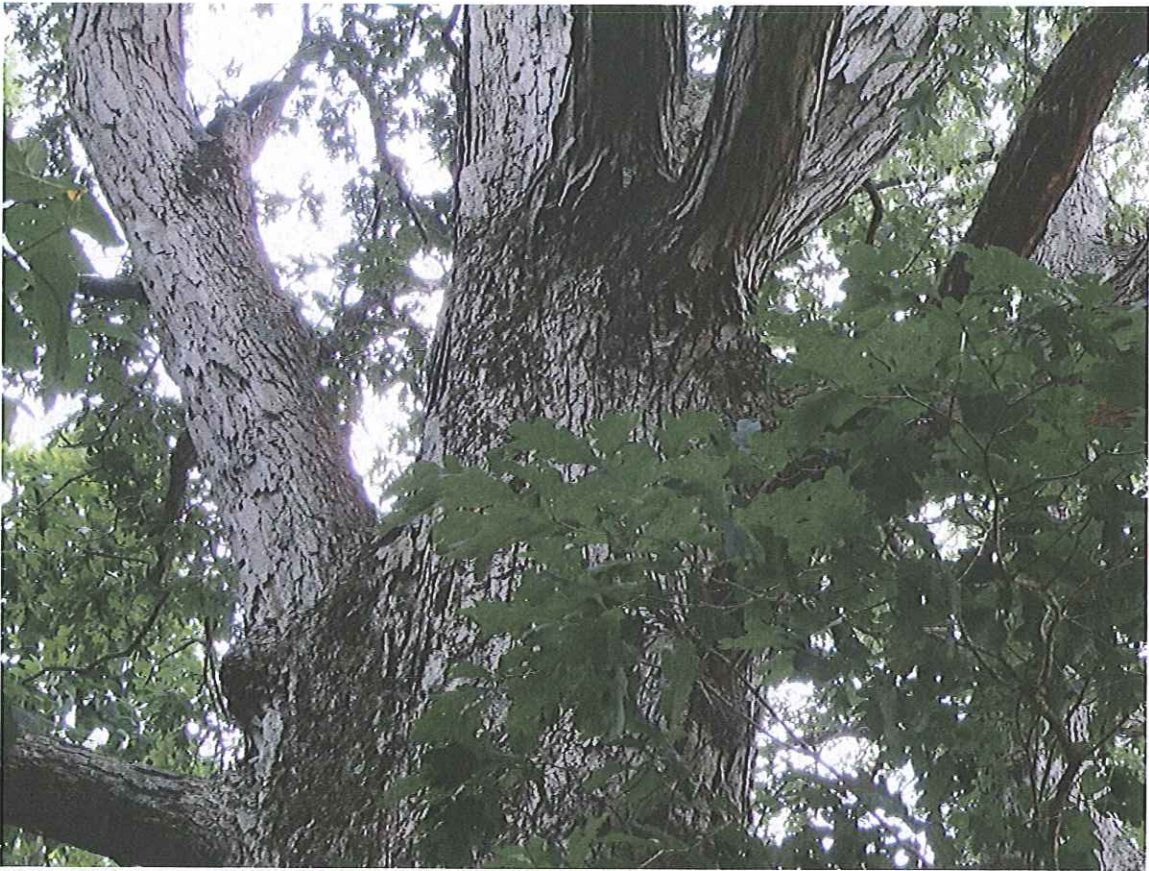
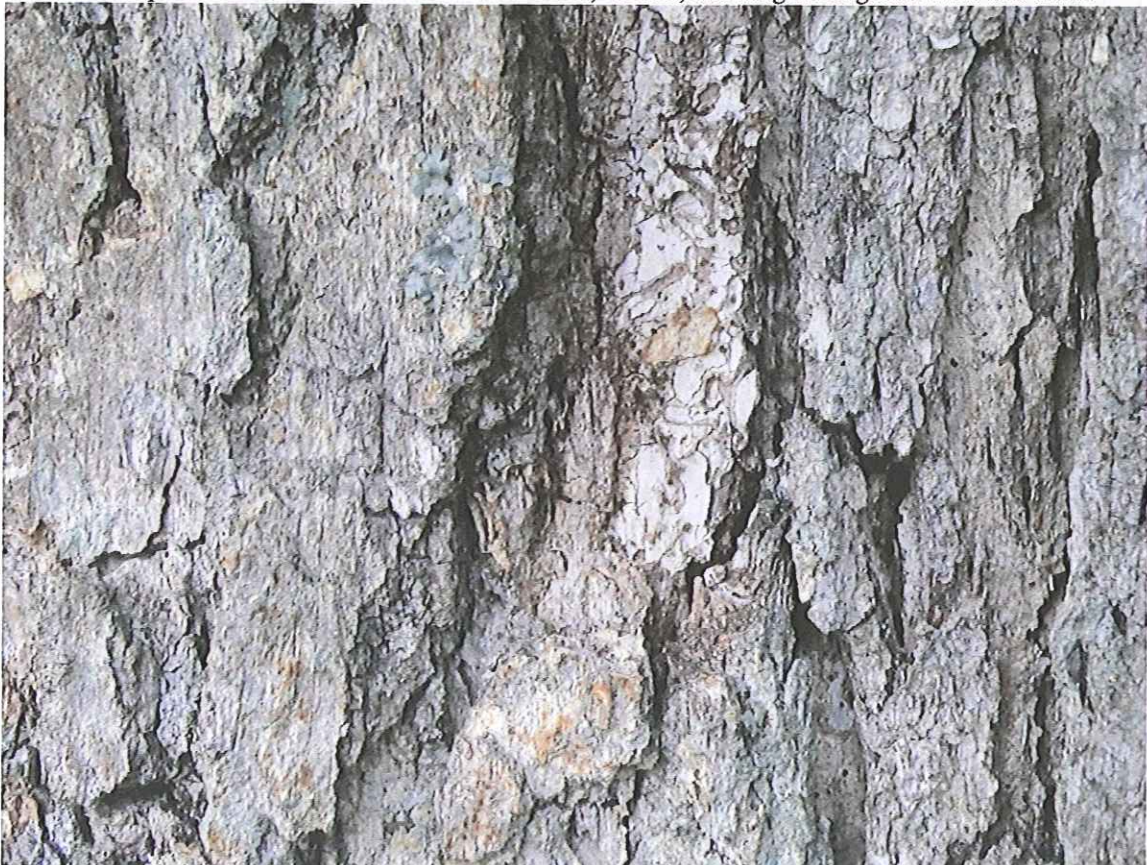
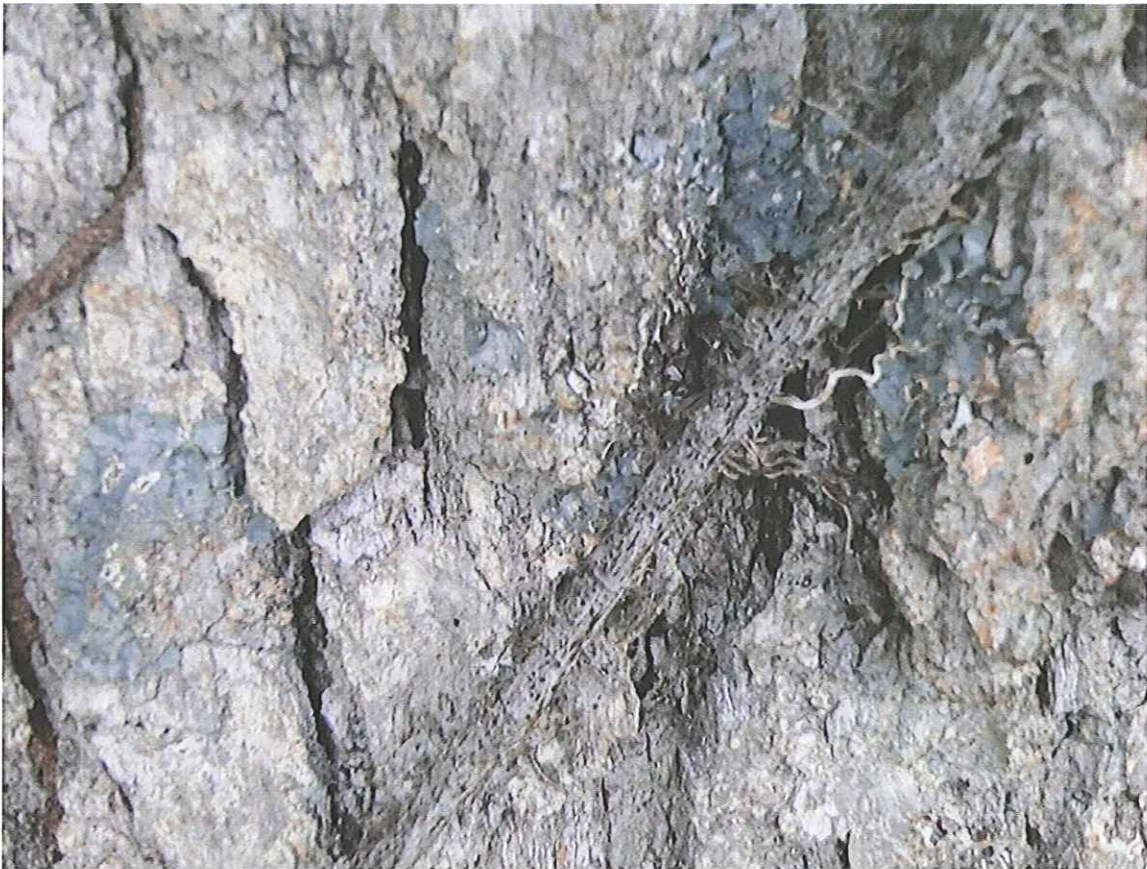
- Moss, lichens and fungi throughout limbs and trunk - Fungi, in most cases, are involved in tree diseases that result in the tree becoming a hazard. A wound occurs, fungus enters the wound and causes a discoloration of the wood, or it begins to rot roots directly with no

wound required. Enzymes produced by the fungus decay the wood, weakening wood fibers. Wood on the internal portions of the trunk or limbs lose strength. Or, the root structure is so weakened that the physical support is greatly reduced. Limbs and small twigs die. The fungus begins to reproduce by forming a mushroom, conk, or shelf-like structure directly on the limbs, trunk, butt, root flares or on roots at some distance from the base of the tree. Larger limbs die and may fall. In the case of root rot, the entire tree may topple in a wind storm.

**Photo #11:** Specimen Tree #1. 35" White Oak – Moss, lichens, and fungi throughout limbs and trunk.

**Photo #12:** Specimen Tree #1. 35" White Oak – Moss, lichens, and fungi throughout limbs and trunk.

**Photo #13:** Specimen Tree #1. 35" White Oak – Moss, lichens, and fungi throughout limbs and trunk.

**Photo #14:** Specimen Tree #1. 35" White Oak – Moss, lichens, and fungi throughout limbs and trunk.

**Photo #15:** Specimen Tree #1. 35" White Oak – Moss, lichens, and fungi throughout limbs and trunk.

**Photo #16:** Specimen Tree #1. 35" White Oak – Moss, lichens, and fungi throughout limbs and trunk.
